# WATER OPERATION AND MAINTENANCE BULLETIN

No. 194

December 2000

- Dam Drain Cleaning – Successes and Failures
- Fence Crossings at Canals
- Bollard Installation at Sims Pond Dam
- Radial Gate, Held in Place Without Bolts for 14 Years, Finally Fails

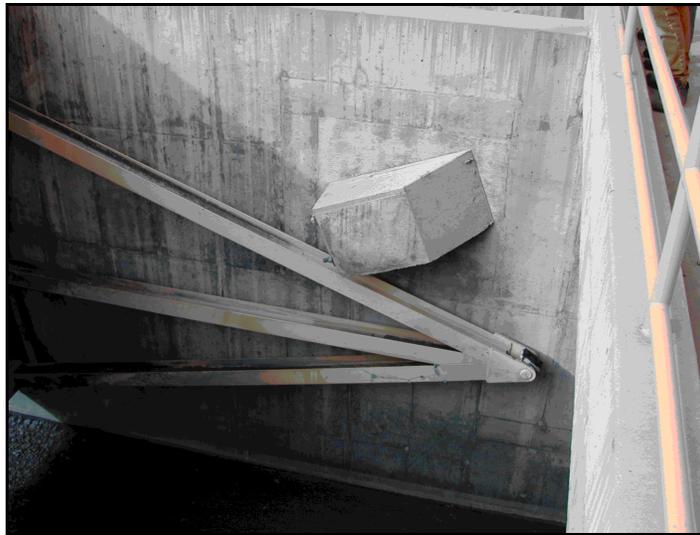
***Cover photograph:*** Failed gate No. 2. Note that the arms have fallen off the concrete corbel support.

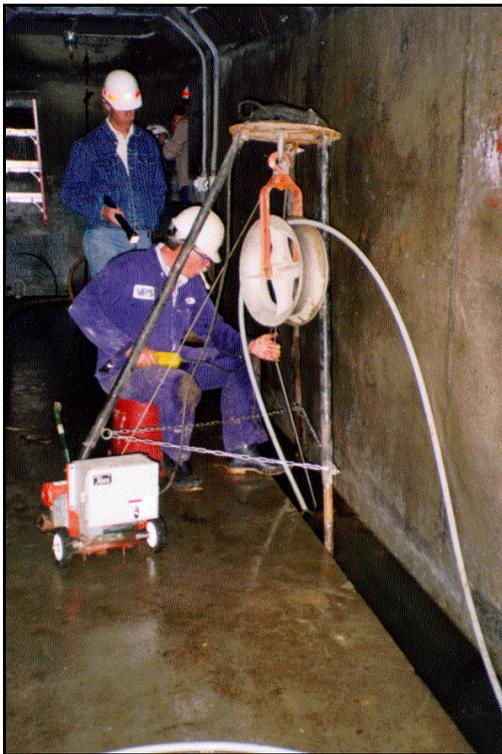
***Figure 1.—High-pressure water jet cleaning of foundation drains.***

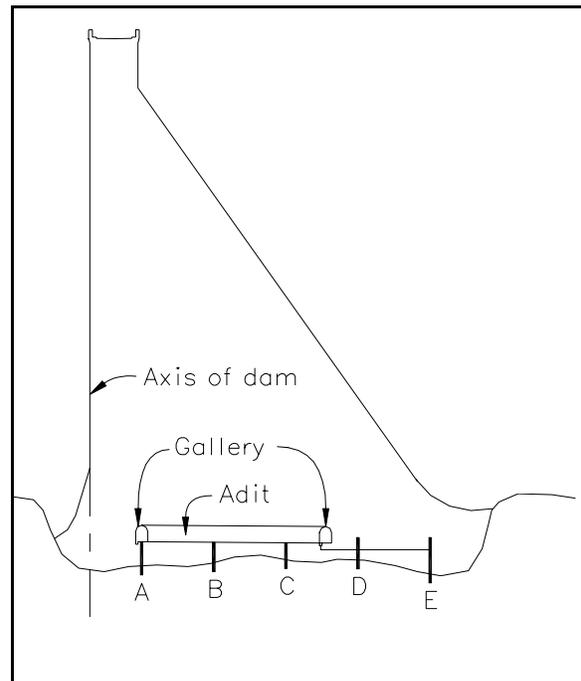
The foundation drains had become plugged with calcium carbonate, as indicated by reduced depths that a probe could be inserted into the drain holes and by increased measured uplift pressures within the dam foundation. Four lines (oriented in the upstream/downstream direction, 5 to 6 pressure pipes per line) of uplift pressure pipes were provided to monitor foundation pressures at the base of the dam. Only one of the lines (line 4) was responsive to changes in the reservoir elevation, and this line indicated uplift pressures greater than the assumed design uplift pressures. Figure 2 shows the locations of the line 4 uplift pressure pipes. Uplift pressure pipe A is located upstream of the foundation drain holes, and the remaining uplift pressure pipes are located downstream of the foundation drain holes.

Figure 2.—Friant Dam, uplift pressure pipes (line 4, Sta. 24+55).

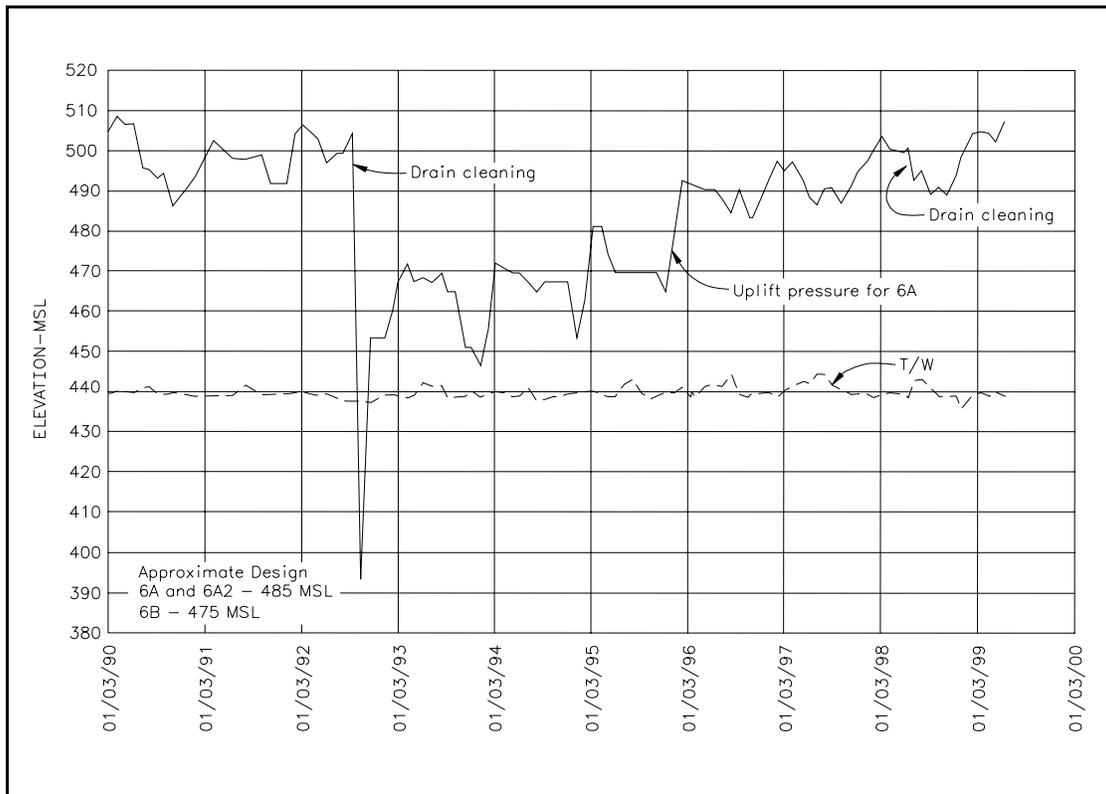
Figure 3 shows the immediate and significant response to the drain cleaning operation. Measured uplift pressures were immediately reduced by 50 feet of pressure. Figure 3 also

**Figure 3.—Uplift pressure response to drain cleaning.**

shows a gradual resumption between mid 1992 and 1998 of decreased effectiveness of the foundation drains until uplift pressures nearly returned to pre-cleaning levels.

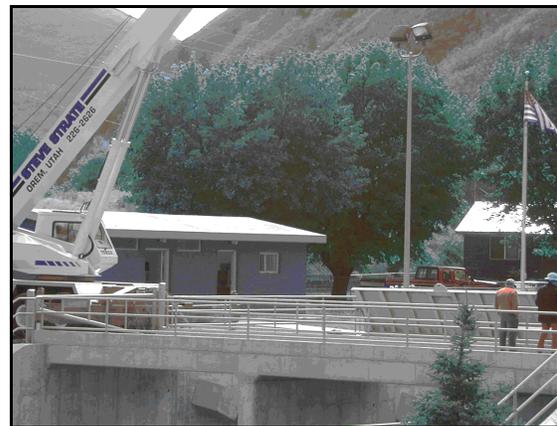
On October 3, 2000, during a routine associated facility inspection at the Spanish Fork Diversion Dam, Utah (photo 1), the middle (gate No. 2) of the three radial gates on the diversion structure failed. The result of one subsequent inspection was shocking: the radial gate, which had no positive mechanical connection to its concrete corbel (for probably 14 years), fell off its support! Fortunately, nobody was hurt and little damage occurred to the radial gate itself. Because of stoplog slots and on-site stoplogs, the canal was back in service the following day, with no significant loss of water. Riverflow was relatively low because it was not irrigation season.

*Photo 1.—Downstream view of diversion structure. A mobile crane removes the middle (failed) gate (No. 2).*

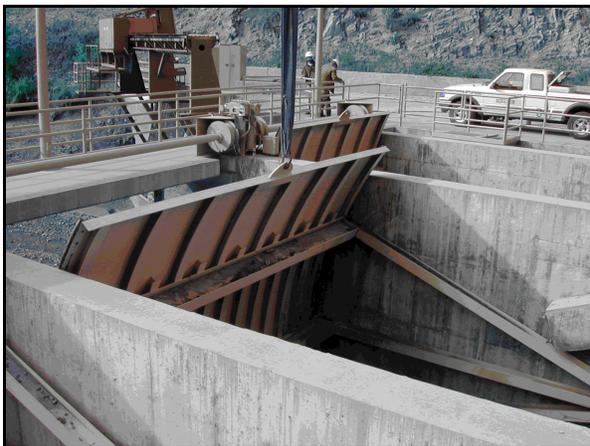
The failure caused both arms of the radial gate to simply fall off the concrete corbel thrust block and into the gate bay (photo 2). The amazing part is that this gate had no positive mechanical connection holding it to its corbel, which in all probability and very interestingly has been for the last 14 years, ever since it was originally installed. It was not until last month, when the gate was routinely exercised from its fully open position to a closed position, that the arms came off the pedestal and fell into the gate bay.

*Photo 2.—Middle (failed) gate (No. 2). Note that the arms have fallen off the concrete corbel support.*

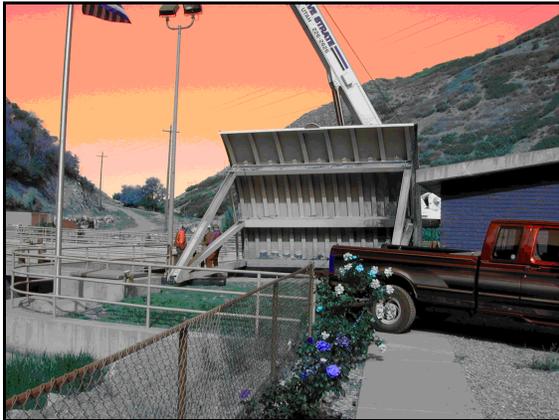
*Photo 3.—The larger 20-foot by 16-foot radial gate (No. 2) is removed from the structure.*

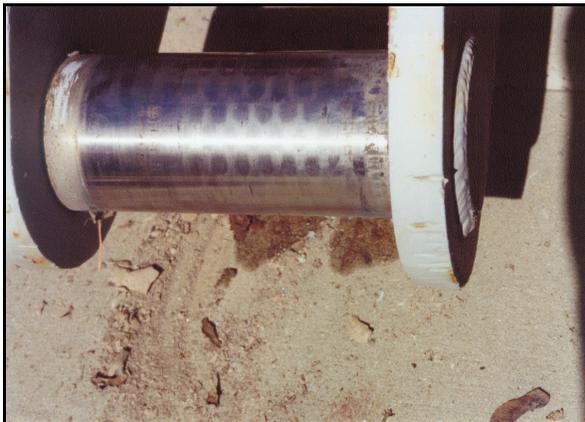
supporting the stiffened faceplate. At the pin end of each of the three arms, two 1-inch-thick plates are welded to the flanges of the beams. The two plates support a 3-1/2-inch-diameter stainless steel trunnion pin (photo 4). Each trunnion pin is welded to the plates.

*Photo 4.—Typical trunnion design. Stainless steel pin (3-1/2-inch diameter) welded on both ends to the 1-inch-thick plates.*

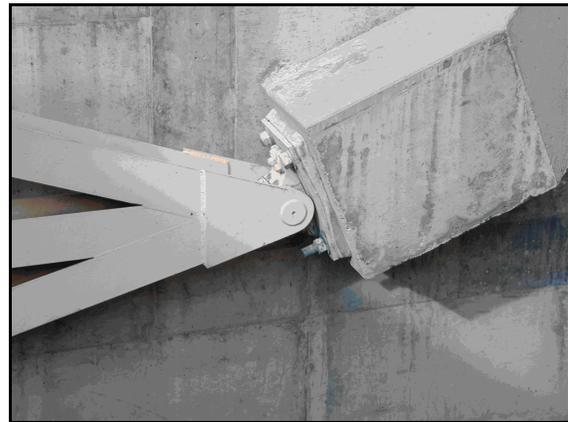
double-nut system to four 3/4-inch-diameter anchor bolts embedded in the concrete corbel (photo 5). In the approximately 1-1/2-inch space between the bearing plate and the concrete corbel, grout provides the bearing surface for transferring the pin loads to the corbel and pier.

*Photo 5.—Radial Gate No. 1, left arm assembly. Note the bent bearing plate, the bearing grout pad, and the concrete corbel support.*

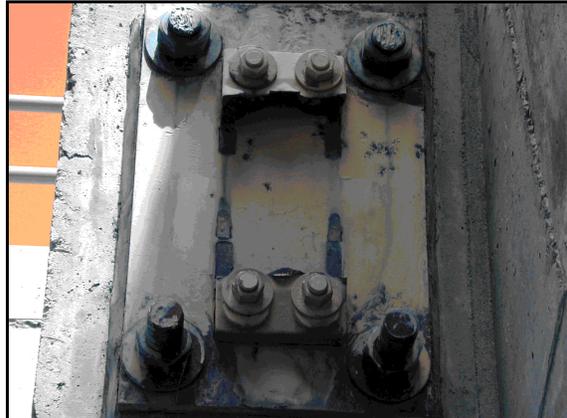
The next day, the gate was removed from the gate bay and set alongside the structure for repairs. The journal bearing on the left side had a tight fit on the pin and could not be bugged. Both cast iron bases on the journal bearings were cracked and broken free from their mounting feet, which were bolted to the bearing (photos 6 and 7). The surfaces of the cracked housing appeared very rusted, an indication that the crack had occurred a long time ago.

**Photo 6.—Radial gate No. 2 (failed) showing the bearing plate attached to the embedded anchor bolts with the failed cast iron journal bearing housing cracked at the bolted connections.**

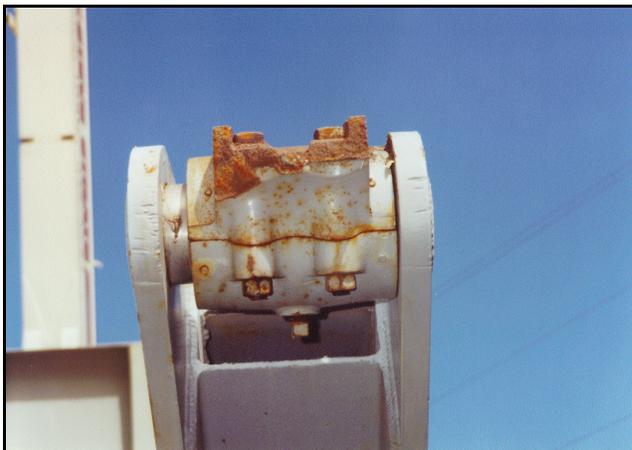
**Photo 7.—End of the radial gate arm assembly showing broken journal bearing attached to stainless steel pin. Note that the cracked surfaces are very rusted and the bearing is completely shifted to the right end of the pin.**

loading the faceplate, the cast iron bearing housing cracked and failed immediately. Failure probably occurred when the water load exceeded the bearings' ratings times its factor of safety.

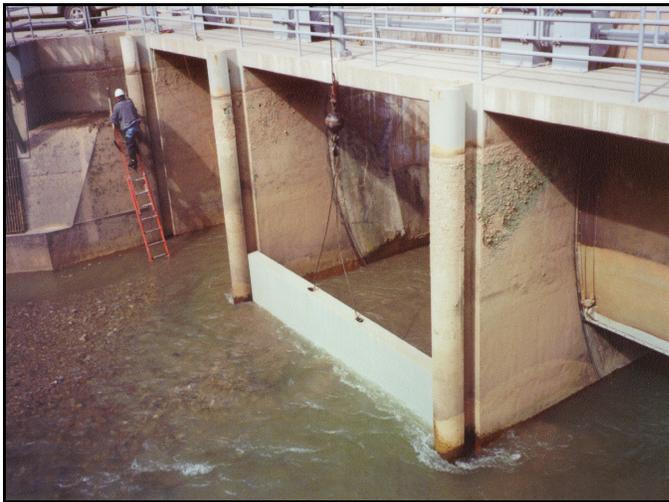
*Photo 9.—Upstream view of diversion structure with the failed middle gate removed and the stoplog installed in the slots.*

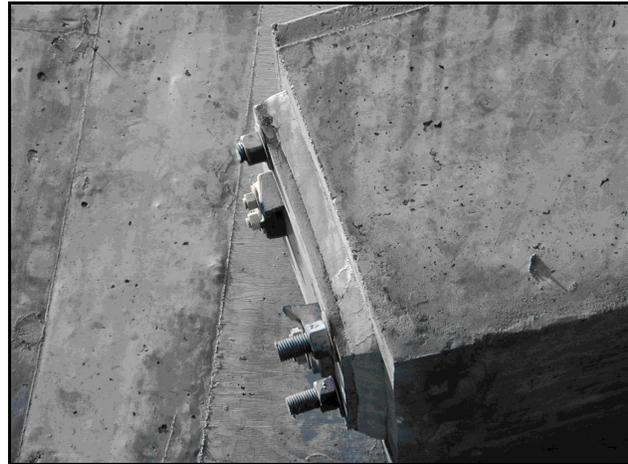
*Photo 8.—Radial gate No. 2 (failed) showing the bent bearing plate with the grout pad behind the bearing plate.*

accumulation of gravel on the sill is uneven. One side of the sill may have no gravel, while the other side has up to 4 feet! When the gate is lowered to rest on this uneven mound of gravel, then the gate faceplate begins to tip and rack, and the arms and pin bearing are subjected to a twisting force. This torque on the bearing journal apparently was enough to pop and free the one broken housing from its mating broken piece attached to the bearing plate. In such a situation, even with an adequately design trunnion pin bearing assembly, a normal bearing assembly is not designed to withstand this amount of torque.
